# Manhole Inspection Summary

Manhole # S69A1\_007MH

Insp Date: **12/1/08 3:00 PM**

**Location** Address: **2100 Van Deman St.**

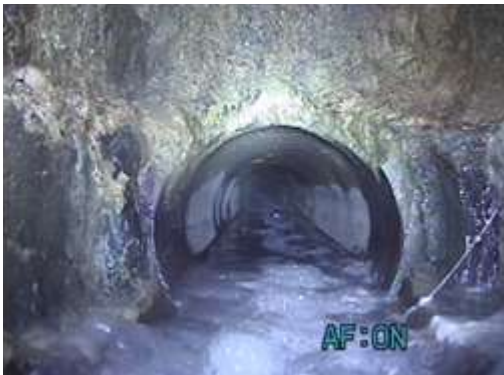
Defect 1

Condition: ☐ Sound ☐ Cracked ☐ Root Intrusion ☒ **Deteriorated** ☐ Leaks ☐ Debris

[dae] Deposits attach encrustation "minerals" along walls, bench, and pipe connections.

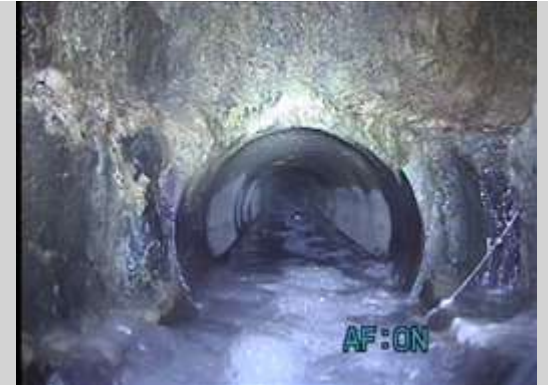
12 O'Clock Outflow

8 in. Circular Gravity Sewer  
Pipe Out @ 12 O'Clock

Pipe Height: **8.4** (in.) Rod and Bar (Angled)  
Pipe Material: **Clay** ☐ Pipe Lined  
Invert Depth: **9.25** (ft.) Flow Characteristics: **Fast**  
Deposits: ☒ None ☐ Mud ☐ Sludge ☐ Debris ☐ Grease  
Silt Depth: (in.) Deposits Extent:  
Infiltration: **None** Pipe Seal Cond: **Sound**

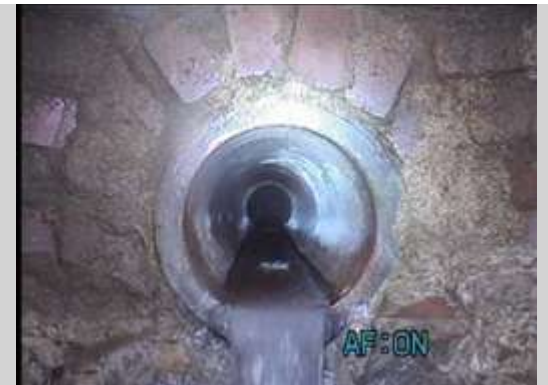
3 O'Clock Inflow

8 in. Circular Gravity Sewer  
Pipe In @ 3 O'Clock

Pipe Height: **8.4** (in.) Rod and Bar (Angled)  
Pipe Material: **Clay** ☐ Pipe Lined  
Invert Depth: **8.00** (ft.) Flow Characteristics: **Fast**  
Deposits: ☒ None ☐ Mud ☐ Sludge ☐ Debris ☐ Grease  
Silt Depth: (in.) Deposits Extent:  
Infiltration: **None** Pipe Seal Cond: **Sound**

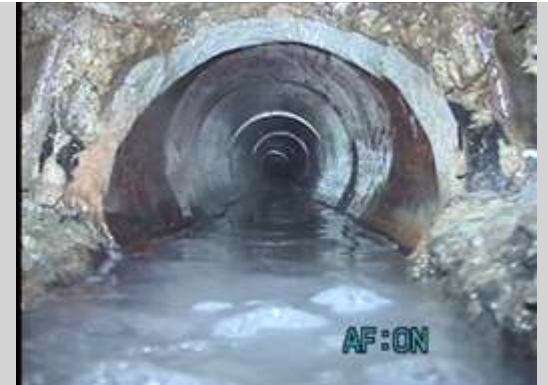
6 O'Clock Inflow

8 in. Circular Gravity Sewer

Pipe In @ 6 O'Clock

Invert Depth: **9.17** (ft.) Flow Characteristics: **Slow**

Infiltration: **None** Pipe Seal Cond: **Sound**
